Contents

1 Introduction

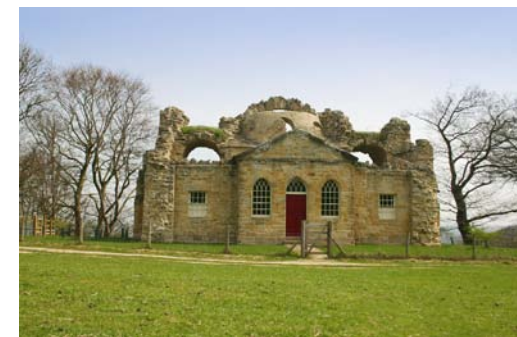
Mowbray Point from the west.

and classical. The field side, constructed of ashlar, is classically arranged being symmetrical and having five bays, of which the central three break forward under a pediment, and the two end bays are set back with hidden roofs. The central part is given further emphasis by the use of Gothic pointed arched openings with narrow piers between, whereas the smaller single windows to end bays are square headed and set in a generous unbroken area of wall.

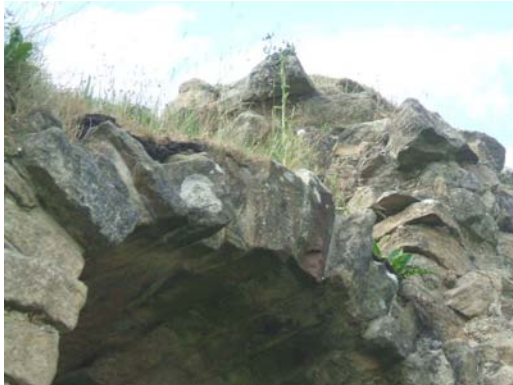
The ruinous face (as designed) of Mowbray Point.

6.8 In contrast, the rear, or east facing side is an apparently ruined building. It is of three bays, the central and tallest is semi-circular in plan topped by a half dome pierced with three roundels. The outer bays are tunnel vaulted with round-headed niches to each side and lunette niches above them. The lower stonework around the doors is ashlar, and rubblestone is used in the "ruined" areas. At the top roughly hewn blocks hang seemingly at the point

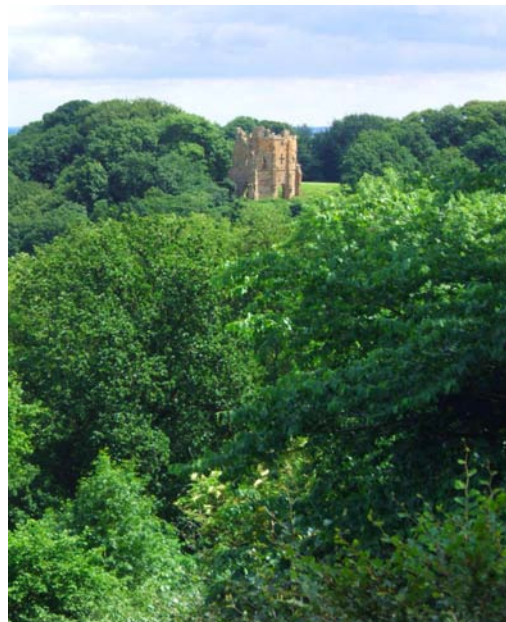
Mowbray Castle seen from Mowbray Point.

6.14 Mowbray Castle was also built around 1750 as an apparent fragment of a Gothic castle. It is two to three storeys high and is an irregular nine sided building

6.15 Each wall has either lancet or cross-shaped openings, and the large central north facing doorway has a pointed arch. This provides the frame to spectacular views over Hackfall to the east, north and west. It appears that a stair once provided access to first floor level to allow better views across the woodland from well above the canopy level.

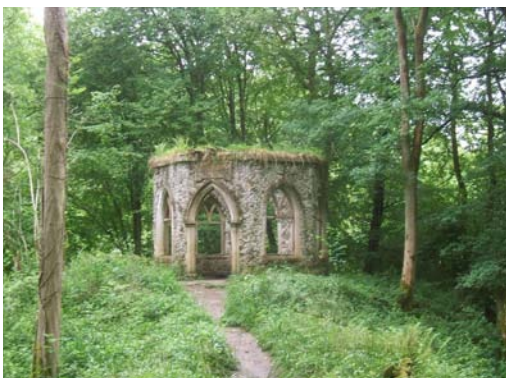
Fisher's Hall.

6.17 The building is roofless and of rubble and ashlar lined with tufa and with an octagonal plan. Artists' sketches show it had a thatched roof of ling (heather). Evidence suggests the thatch was placed, unusually, on top of stone slates with substantial overhanging eaves and a domed ceiling in tufa. Seven of the elevations have a pointed arched head window, some with remnants of joinery in oak showing a Y tracery pattern. The north elevation has a doorway with a moulded stone doorcase with pointed arch. The doorway does not directly face the raised path which provides access, but the orientation of the octagonal form is designed to maximise the viewing potential from its pointed arched windows.

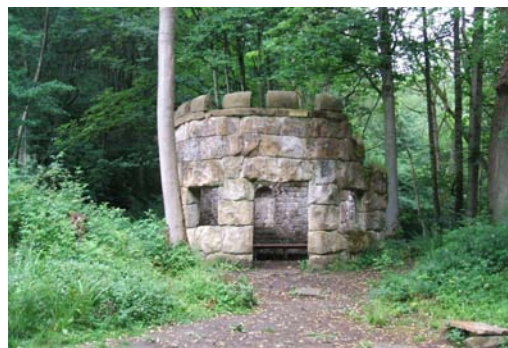
The Rustic Temple.

6.18 The Rustic Temple has five sides. It is built of large blocks of local sandstone so massive and rough in character as to evoke the primitive. The top of the wall, formerly a parapet when the roof was in place, is crenellated. The square-headed door and window openings have massive stone lintels over, and opposite the door is a round-headed niche. The extreme plainness of the rear of the building suggests close planting to screen all views from the north. The building faces Fountain Pond and enjoys a southerly aspect.

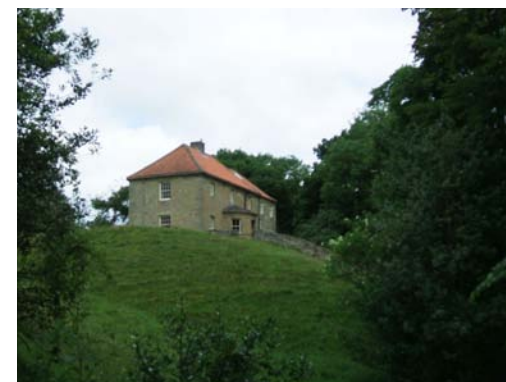
Hackfall Farmhouse from the dam.

6.20 The building is of coursed squared stone with quoins, and has a hipped pantile roof with a central stack. Typically, buildings in the area have simple pitched roofs, so although the architectural detailing is not ornate, the building would have stood out from other farmhouses. The building is of three bays, having a central six panel door with a bracketed hood mould. The windows are mainly Yorkshire sliding sashes of six panes each.

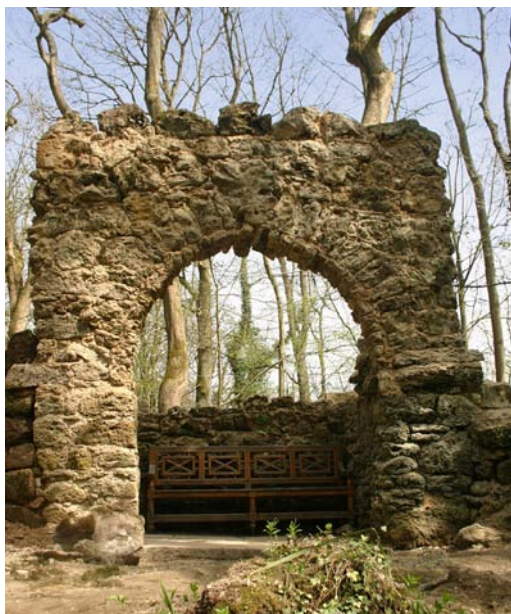
The Grotto.

- 6.22 The Grotto seems to have been built specifically for a single view ahead to the Forty Foot Fall (and Mowbray Point above the falls). The structure of The Grotto, and its surrounding trees, formed a view from shade into light. The Grotto is little more than a covered seat. It is rectangular masonry building with no roof (it once had a barrel vault in tufa, possibly with a single pitched roof over it). The remaining stonework is of two leafs, the outer of coursed rubble sandstone and the inner of tufa. The opening to the west elevation is an arch following the Gothic theme.

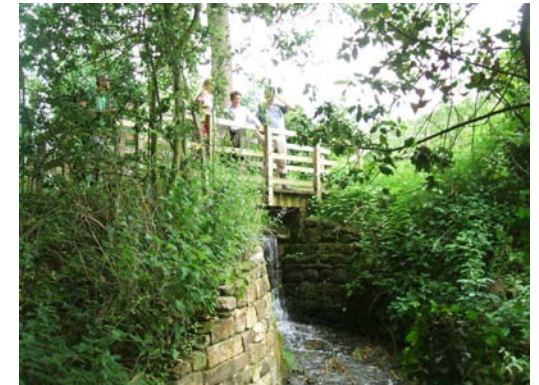
The bridge over the dam.

- 7.20 There were a series of ponds, which may have had their origins in waterworks associated with a mill. The remaining pool at the top of the wood is outside the Historic Park and Garden boundary. The pool may have been "improved" as ornamentation for the semi-circular room added to the east front of Hackfall Farmhouse, although now the Farmhouse is not highly visible from beside the pool. The bridge over the dam is quite new and provides an interesting entrance to the wood proper. The sound of the water over the dam temporarily obliterates other noises.
