WESTON

Conservation Area Character Appraisal

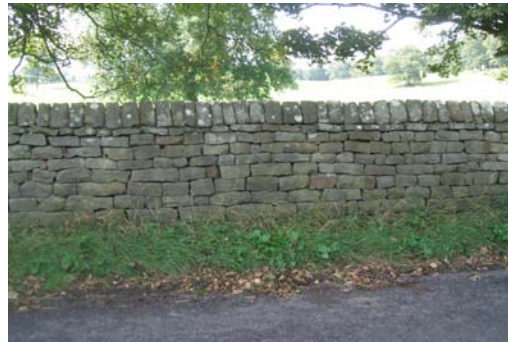
Pennine dry stone walling is by far the most common boundary feature in the Conservation Area.

- 5.21 The predominant boundary features used in and around Weston are traditional dry stone walls, which form field boundaries as well as boundaries to private curtilages, including Weston Park and the churchyard. Notable exceptions are the railings to the front of Weston Manor, the timber rail and stone post boundary along the west side of Church Lane and the triangular coped retaining wall to the rear of the Hall.
- 5.22 There are few instances of hedges forming boundary features in the Conservation Area, but where they exist they complement the prevailing rural character of the area.

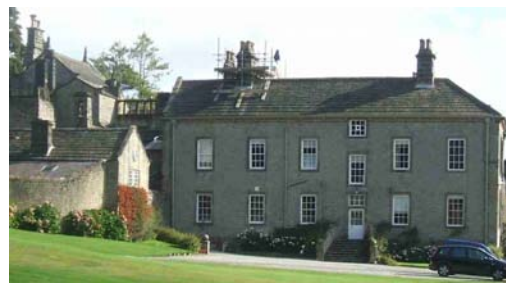
The western elevation of Weston Hall. The late Tudor north wing is the tall gabled structure on the left. The formal Classical western front dates from the early eighteenth century but conceals an earlier building.

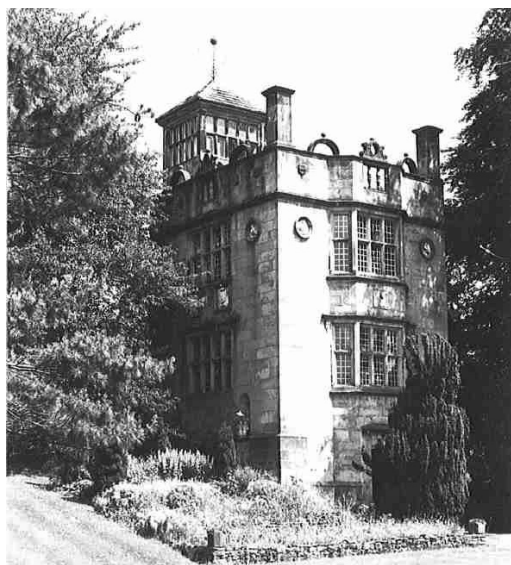
A 1986 photo of the banqueting house at Weston Hall. Unlike the Hall itself, the late Tudor banqueting hall has seen few alterations.

canted bay windows. The building is faced with ashlar and gritstone and has ovolo moulded double chamfer cruciform mullion windows, much like the north wing of the Hall. The four sides of the gazebo are full width five light mullioned double chamfer mullion windows. The roof is concealed by a parapet which is surmounted at the corners by corniced square chimney stacks. The banqueting house would have been used for entertaining guests, providing excellent views over the Park and Wharfedale. Not every hall had such a building, and very few survive to this day.

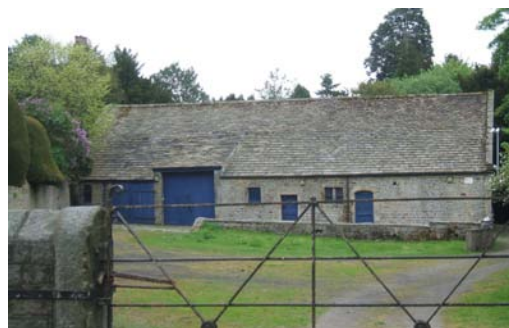
The barn at Weston Hall. Its timber structure dates from the fifteenth century.

The barn, much like a church, consists of a high central nave which is flanked by two lower aisles, with the nave separated from the aisles by a series of structural posts. The lower roof levels of the aisles mean that the tall cart entrance was given its own catslide roof to maintain the required opening height. The barn has coursed gritstone elevations and a long stone slate roof terminating in copings and shaped kneelers. The openings relate to the building's former uses.

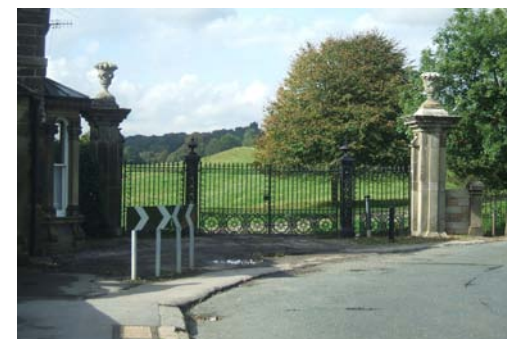
The east gates to Weston Park

- 6.8 At the other end of the Park, the east gates incorporate fabric from three different eras. The ashlar Classical piers with a richly moulded cornice date from the mid-eighteenth century, but the weathered urns which top these piers are similar to urns at the banqueting house, suggesting they were moved here from an earlier gateway, quite possibly the gateway halfway along the drive shown on the 1852 Ordnance Survey. The wrought ironwork dates from the late nineteenth century and include the gate leaves with decorative flower motifs and the elaborate openwork inner piers.

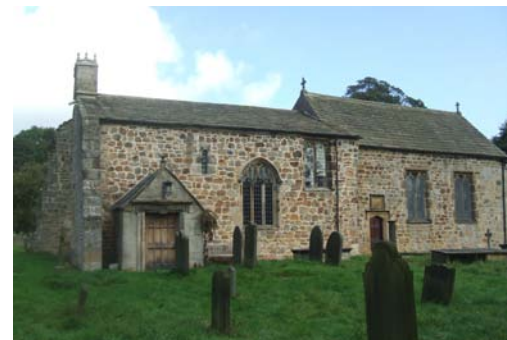
All Saints Church. Note the slender twelfth century lancet opening to the right of the porch, and the massive buttress to the left hand gable.

of the porch. The porch is dated 1686 and it is likely that other repairs and alterations occurred around this date. Further repairs to the nave were carried out in 1819, along with the construction of the vestry on the north side of the nave, and it is probable that the chancel roof was raised higher than the nave at this time. The 1819 repairs and alterations (and close links with Weston Hall) meant the Church was spared the Victorian era 'restoration' of thousands of other parish churches in the country, which in fact rebuilt many old churches and removed historic fabric from earlier eras to achieve what was deemed to be the building's 'correct' style! As such the nave of All Saints retains the squat, broad proportions of a northern parish church. The walling is a mixture of coursed gritstone rubble and squared blocks with ashlar details. The church has no tower and instead there is a double arched bellcote at the apex of the western gable. There is a massive stepped buttress between the nave and northern aisle on the western gable.

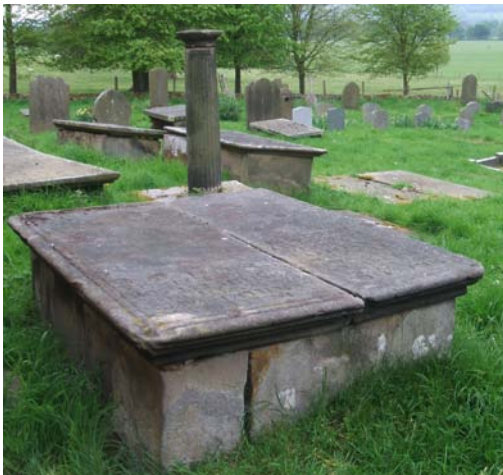
The Grade II Listed sundial, and in front of it the Grade II Listed pair of table tombs in the churchyard

- 6.10 There are three grade II listed structures within the churchyard. The sundial to the south of the Church dates from the late eighteenth century. It consists of a fluted circular gritstone column on a square base. The moulded capping has been reconstructed in recent decades following damage. Nearby is a pair of table tombs dated 1669 and 1671 for William Ward and his daughter Elizabeth. The large gritstone slabs have roll moulded edges. Three other table tombs are to the east of the Church. One is dated 1698 and all three gritstone slabs have squared edges.

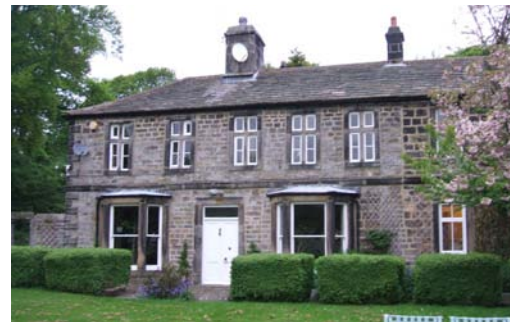
- 6.11 Weston Grange would have been a house of considerable status in Weston, judging by its size and the level of ornament given to its principal south-facing façade. The original five bay frontage dates from the late seventeenth century. It has a hipped stone slate roof and a substantial chimneystack. Decorative features included the projecting ashlar quoins with chamfered edges, the moulded stone string at first floor and the moulded architrave to the doorway. The cruciform square mullion windows at first floor also date for this time. The Grange was altered and extended in 1890. The two eastern bays were added and at ground floor the two canted bay windows were inserted.

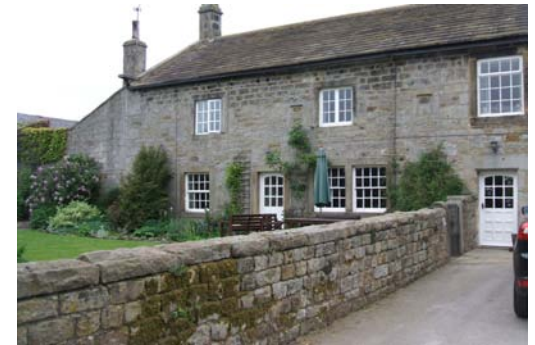
- 6.12 Hall Farmhouse is a mid to late seventeenth century vernacular building with late eighteenth or early nineteenth century alterations. The quoins on its south-facing front elevation indicate the original extent of the house, which was extended by a bay into the adjacent barn, hence the larger first floor window and quoined doorway in the rightmost bay. The squared plain stone reveals to the sash and casement windows all date from the building's later alteration. Curiously, elements of seventeenth century window openings remain. These are the small square niches at first floor and the jambs of former window openings either side of the ground floor windows.

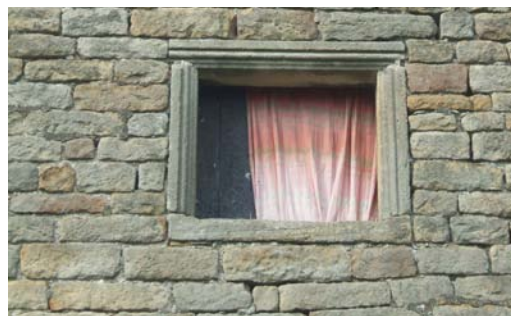
Gritstone. Although harder to work than sandstone, this rugged material was the most easily obtainable building material in Weston. The predominant use of sandstone in nearby Otley heightens the visual differences between these neighbouring settlements.

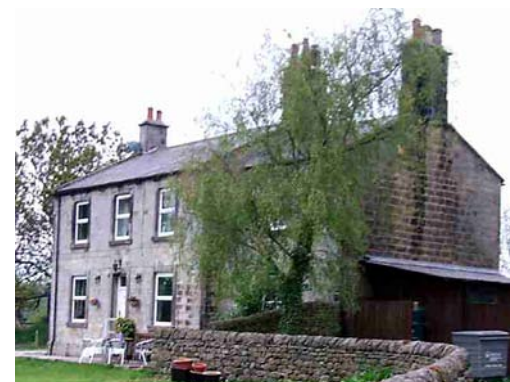
Cock Pit Farm. The regular spacing of tall openings on this vernacular buildings gives a well-proportioned 'no frills' version of the Classical architecture found in towns.

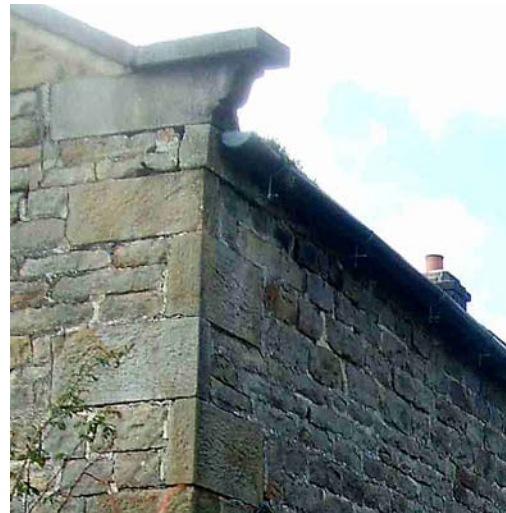
Quoins are found on both the vernacular buildings and the more architecturally stylized buildings in Weston.

- 6.22 Quoins (large corner stones) are a common feature of buildings of all ages in Weston. The quoins are regular and identically sized regardless of building age or status.

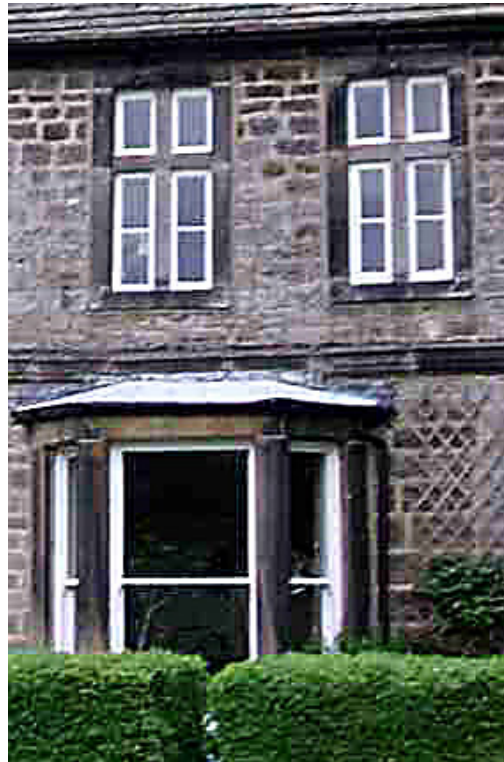
Weston Grange: one elevation, two different eras, two different window types. At first floor the mullioned and transomed casement windows are original to this late seventeenth century building. The large single paned sash windows were inserted in 1890.
